Air disc brake maintenance

Meritor Air Disc Brake Evolution

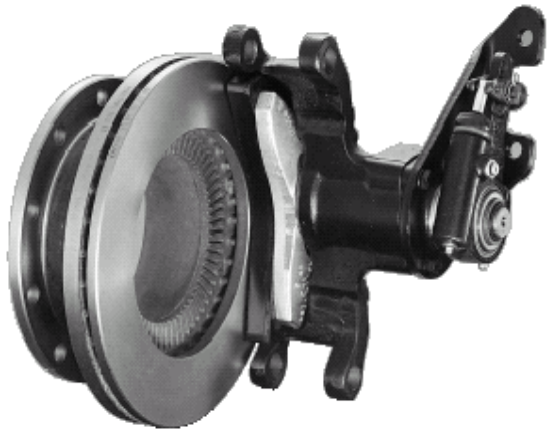
ADB-1560

**External Slack
External Auto Adjust**

1980

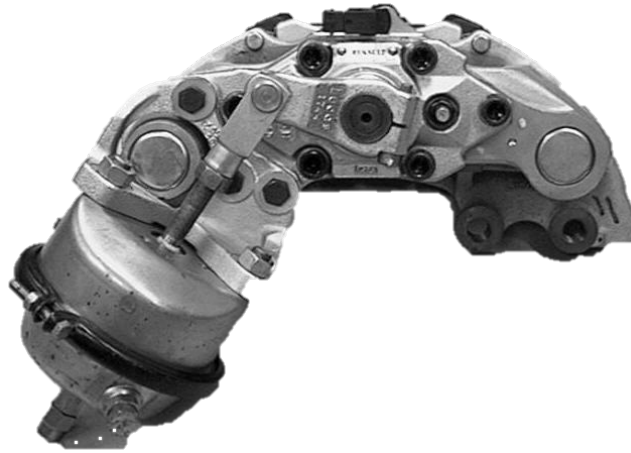
D-LISA

**External Lever
Internal Auto Adjust**

1990

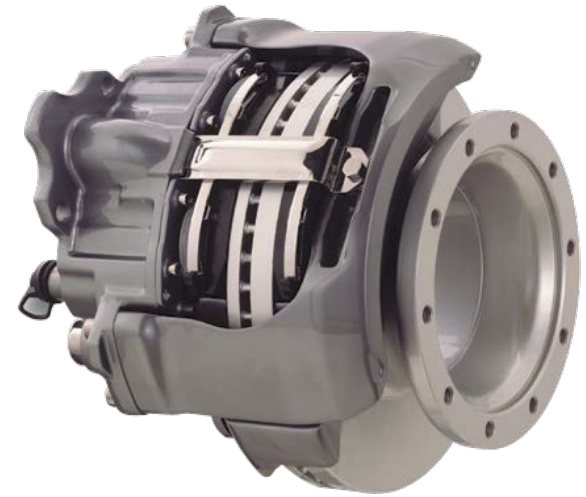
EX +

**Internal Lever
Internal Auto Adjust**

2003

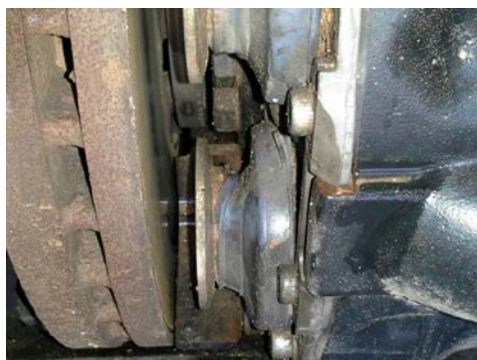
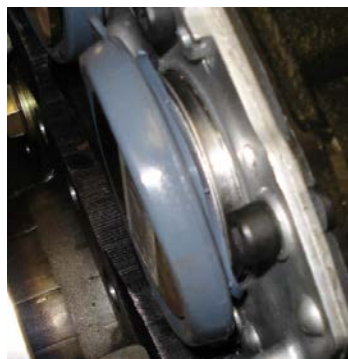
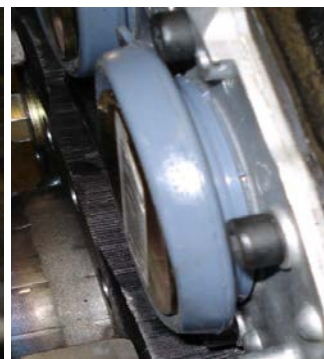
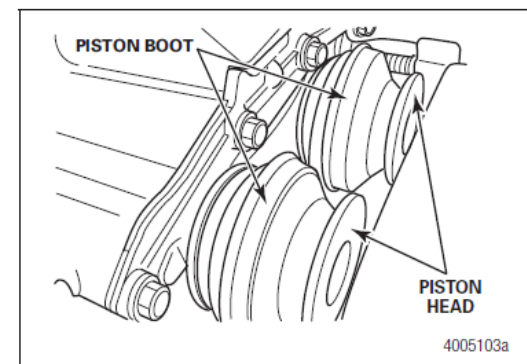
Piston Boot damage

Principal Cause	Effect	Repair options	Prevention / Detection
Debris damage. Heat Damage.	Seizure of clamping mechanism due to water ingress.	Service Piston Boots. New Housing. New brake.	Visual inspection & Operation check at maintenance interval

Notes:- EX+ boots replaceable “in-situ” with effective secondary sealing.

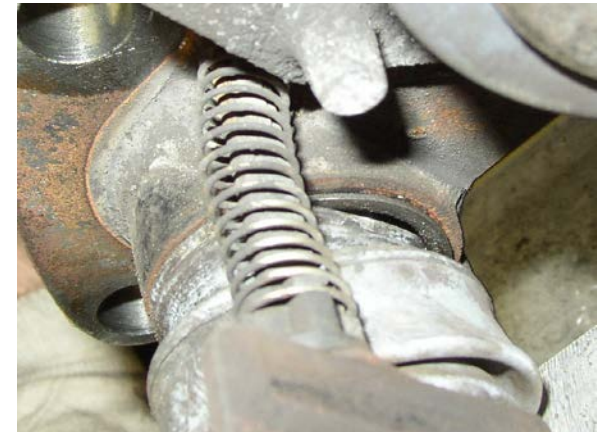
Slide pin Boot damage

Principal Cause	Effect	Repair options	Prevention / Detection
Debris Damage. Heat Damage.	Seizure of sliding system due to water ingress.	Service slide pin Boots. New brake.	Visual inspection & Slide check at maintenance interval

Notes:- EX+ H brakes with standard Stainless slide pins.

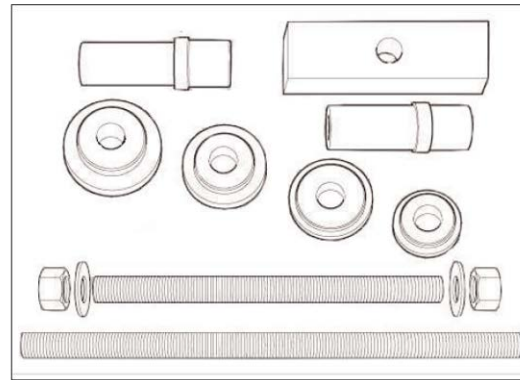
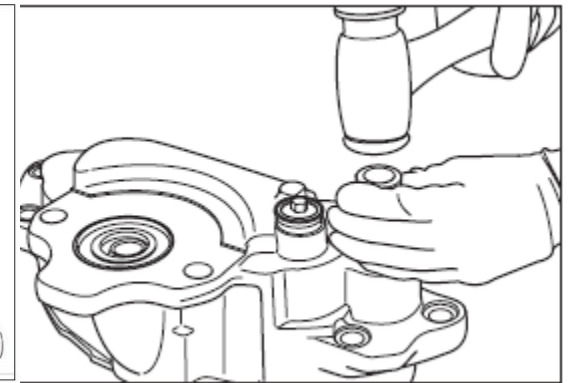
Fig 11.7

“play” in slide pin bushings

Principal Cause	Effect	Repair options	Prevention / Detection
Bushing wear – rough roads / high mileage	Rattle of brake assy.	Service bushings. New housing. New brake.	Measure play at periodic inspection.

MST 1000 - Bush fitting tool

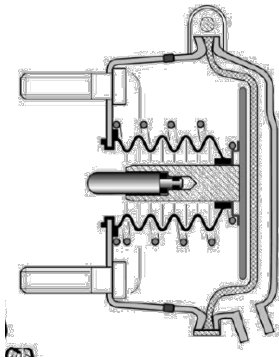
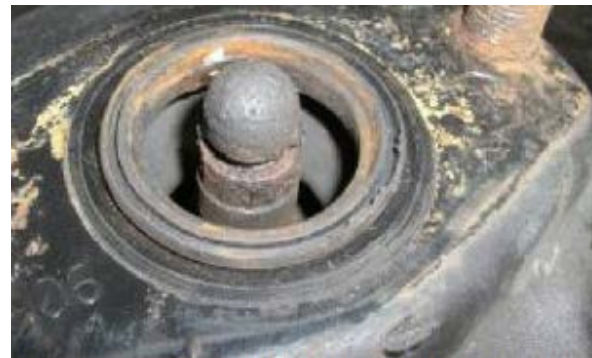
Water in brake housing mechanism

Principal Cause	Effect	Repair options	Prevention / Detection
Leaking Air chamber.	Brake has difficulty applying or releasing.	New housing assy. New brake.	Use of High quality air chambers only. Visual / Vacuum Inspection check

Corrosion on ball end of actuator and liner part of seal

Notes:- Replace air chamber at same time to prevent re-occurrence

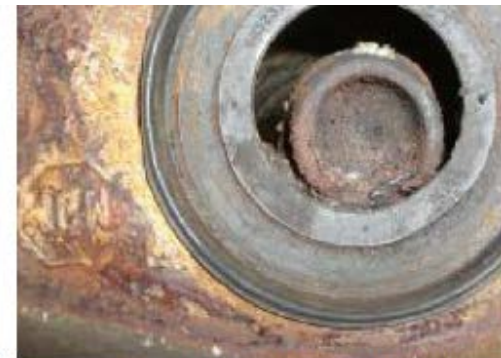
Corrosion inside the brake housing

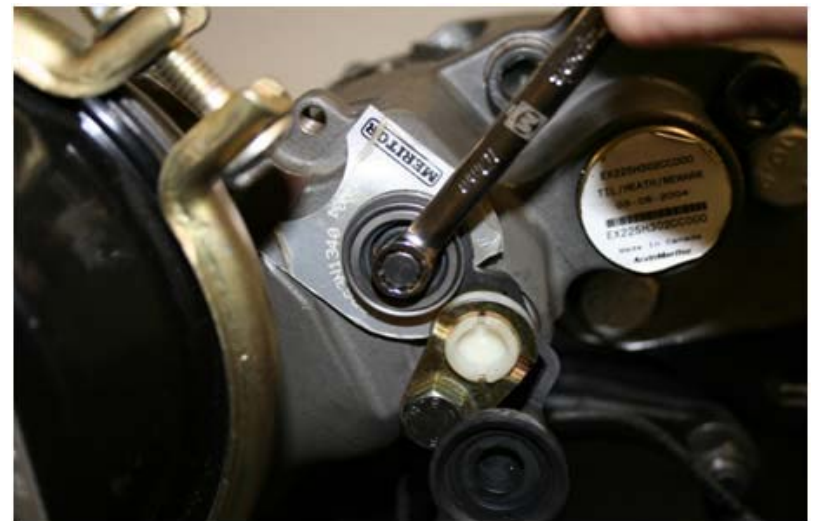
Adjuster damage

Principal Cause	Effect	Repair options	Prevention / Detection
Mechanic abuse	Inability to adjust. Damage to brake mechanism.	New housing assy. New brake.	Mechanic training. Do not use power tools. Adjuster function check.

EX+ designed to handle high abuse torques without damage.

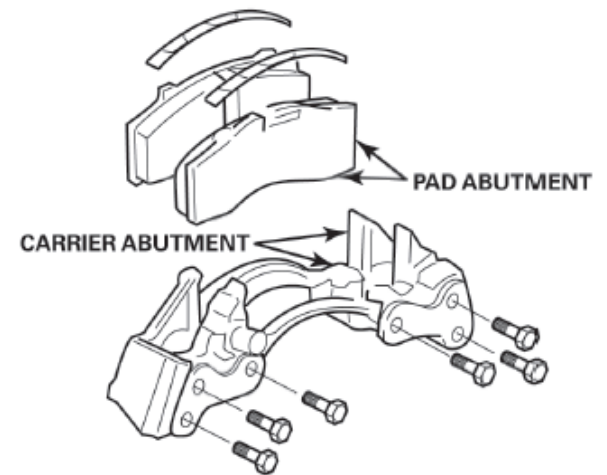
Carrier abutment wear / Grooving

Principal Cause	Effect	Repair options	Prevention / Detection
High vibration / environment combined with very slow pad wear rate	Pad slop / uneven pad wear.	Replace brake carrier. New brake.	Visual inspection at maintenance interval.

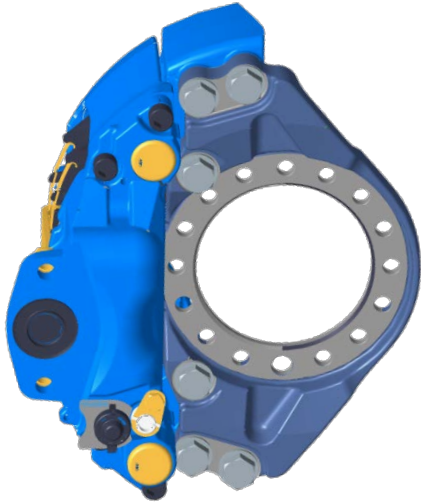
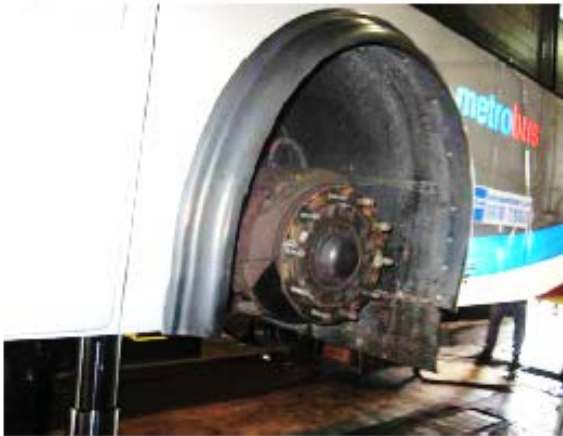
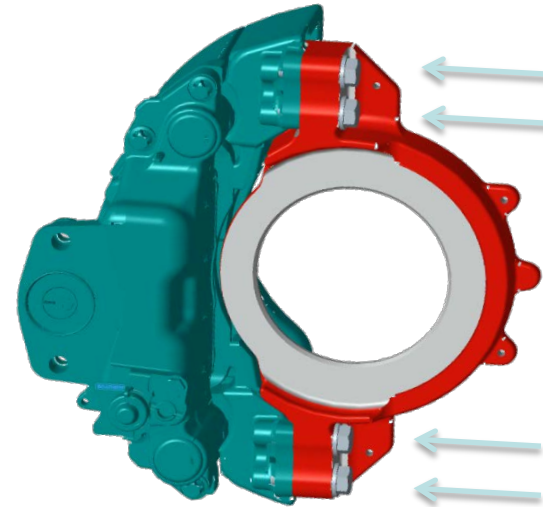
Servicing benefits of radial mount calipers

- Restricted bolt access

- Mechanic is beside vehicle at the end of the axle rather than under.
- Caliper mounting bolts are accessed in ergonomic position.

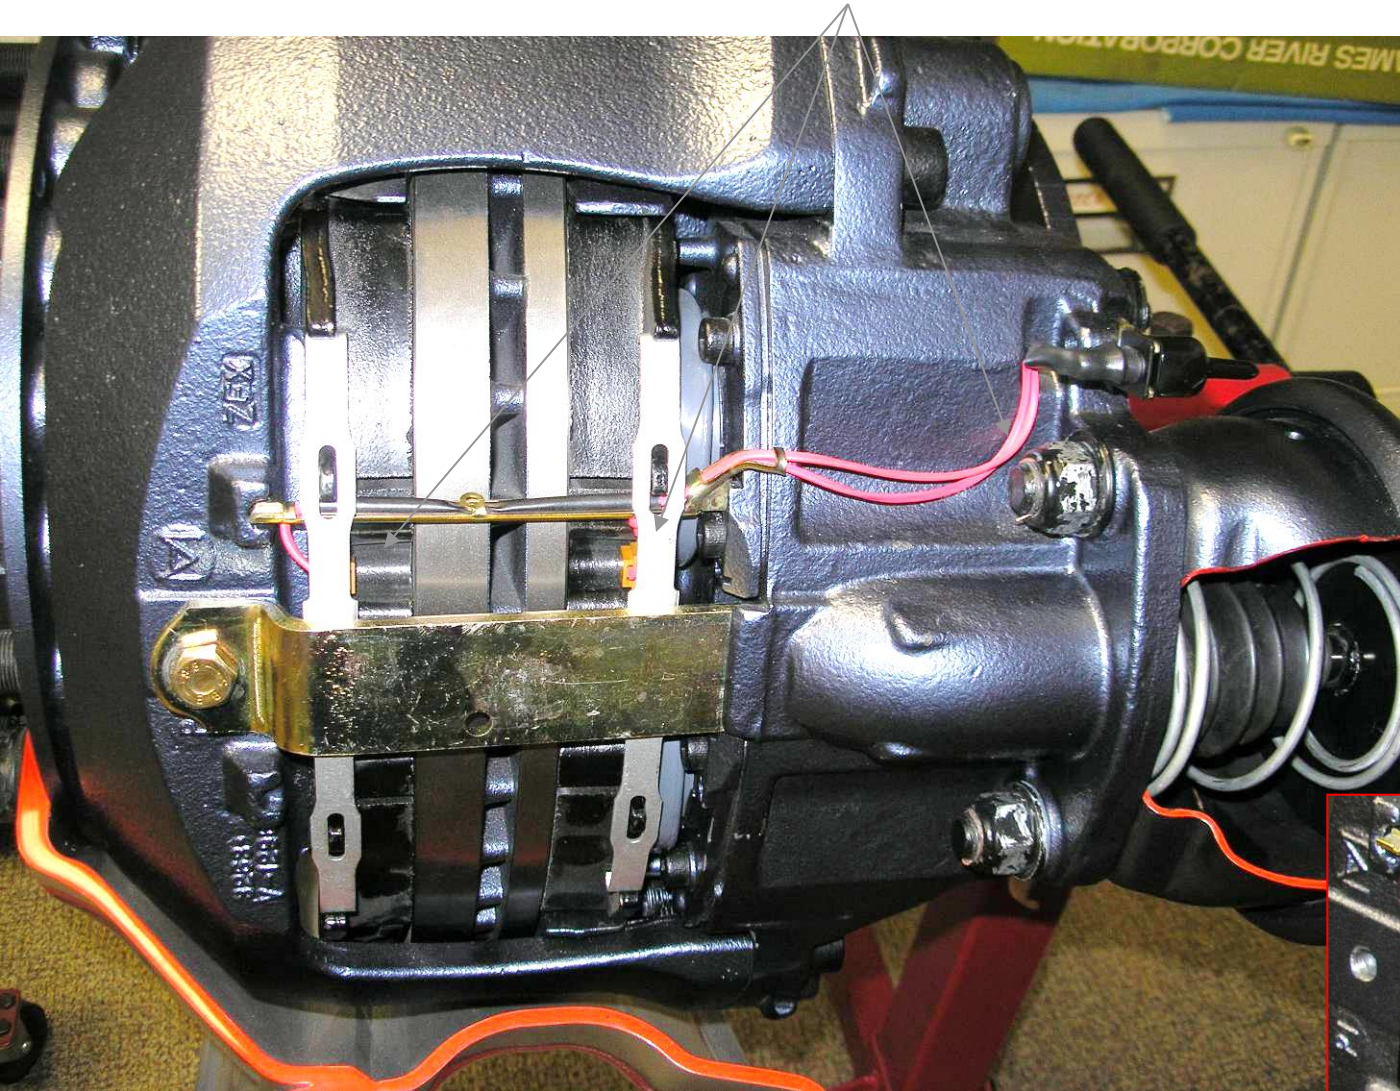
Pad Wear out sensing

Loop of wire goes through both pads on each brake
